Ship Explosions: *USS Maine, SS Fort Stikine, SS Mont Blanc*

USS Maine, 15 February 1898.

SS Fort Stikine, 14 April 1944.

SS Mount Blanc, 6 December 1917.

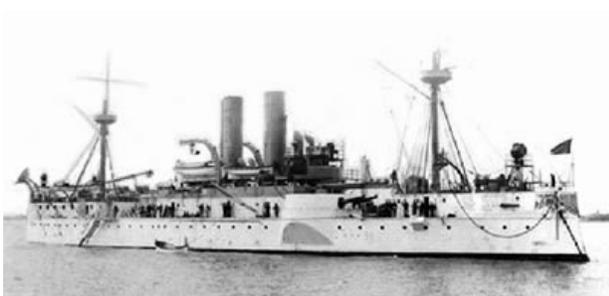
USS *Maine*, circa 1895-1898

USS *Maine* was a 6,682 ton second-class battleship built at the New York Navy Yard and commissioned in September 1895. The precipitating cause of the Spanish-American War (21 April-13 August 1898)

was the explosion and sinking of the *Maine* in the harbor of Havana, Cuba, at 9:40 the evening of 15 February 1898. More than five tons of powder charges for the battleship's six- and ten-inch guns exploded, virtually obliterating the forward third of the ship; 260 American servicemen were killed in the explosion. Debate has continued for 100 years whether the *Maine* explosion was caused by spontaneous combustion and undetected fire in the battleship's coal bunker, the heat of which detonated the ship's adjacent forward powder magazine, or if the detonation of a naval mine placed against the ship's hull by unknown saboteurs had caused the magazine to explode.

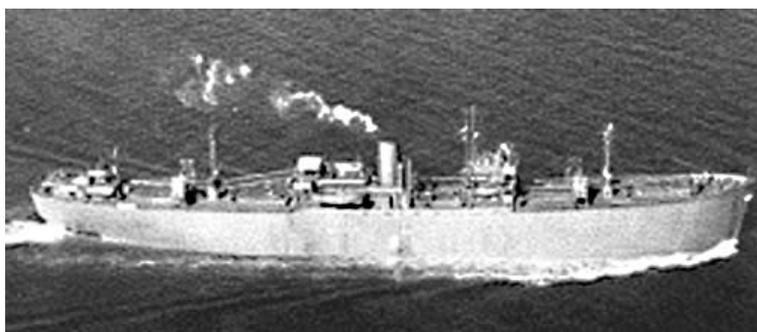
SS Fort Stikine, North Sands Class freighter.

SS Fort Stikine was a coal burner of 7,130 tons, 441 feet of length and carrying 1,395 tons of wartime munitions. Cause of the explosion was spontaneous combustion among 9,000 bales of cotton, loaded at Karachi, that were a part of her cargo. Of fringe interest, *Fort Stikine* carried among her cargo 124 gold bars each weighing 28 pounds, valued in total at two million Pounds Sterling (\$1,821,000). The gold had been shipped from London to stabilize the Indian currency, the Rupee, then sagging in value because of wartime economic disruptions and fear of an invasion of India from Japan. The ship explosion blasted those gold bars throughout the immediate area onshore and into the harbor waters. Most of the gold bars are reported to have been quickly recovered from different parts of

Fort Stikine was one of 90 Canadian-built wartime cargo vessels of the North Sands Class that were very similar to the U.S.-built Liberty ships; *Fort Stikine* was built and launched July 1942 at Prince Rupert Drydock & Shipyard, Prince Rupert, British Columbia, Dominion of Canada, purchased by the U.S. War Shipping Administration and transferred to British operation and ownership. The ship's principal cargo was wartime munitions, but before coming into the Victoria Docks at Bombay she had made a number of port calls along the Indian Ocean coast to take on whatever additional cargo the crew could manage to squeeze into her holds and onto her deck. At Karachi she took on the cotton bales that would ultimately destroy 18 ships and a large part of Bombay.

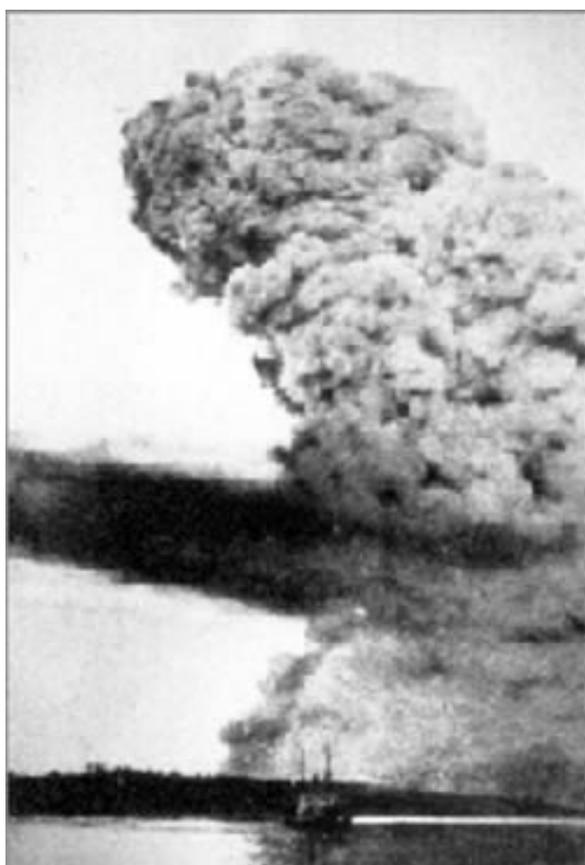
Smoke cloud formed above the explosion of the SS *Mont Blanc*.

The captain, pilot and crew of the *Mont Blanc* knew the ship carried an explosive cargo of 200 tons of TNT, 10 tons of gun cotton, 25 tons of benzene, and 2,300 tons of picric acid. They expected the ship would explode immediately. They launched the ship's lifeboats, abandoned her, and rowed with all haste to the Dartmouth shore where they warned everyone they passed to take cover as they ran to refuge behind a low hill; all the crew of the *Mont Blanc* were saved except one of the crew who was fatally injured by one of the 3,000 tons of steel fragments of the ship blasted miles through the air when the ship exploded at 9:05 A.M., 20 minutes after she was abandoned. The massive smoke cloud formed above the explosion of the *Mont Blanc* is said to have risen one mile (5,280 feet).

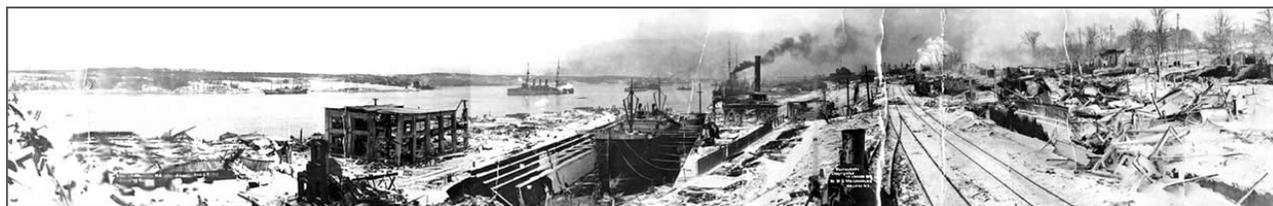
View of the Halifax disaster, looking south, 6 December 1917

The blast wave flattened almost all buildings within an area of two square kilometers, converting the mostly wooden homes and structures to kindling wood; 1,630 homes were destroyed. Then the tidal wave from the explosion rushed ashore and many of the injured and uninjured in downtown Halifax were drowned. The water wave raced across the harbor to the Dartmouth shore, swamping and sinking ships and boats as it moved. On the Dartmouth shore the wave gained intensity as it funneled into Tufts Cove where it washed away the entire settlement of Micmac Indians encamped there. In Halifax, fol-

lowing the rain of steel fragments, many coal- and wood-burning stoves that were overturned and thrown around by the blast wave ignited the rubble of buildings collapsed by the blast wave and 325 acres of the city burned. That night a blizzard burdened the city's
